2024 Infrastructure and Energy Reduction Project

Prepared for: School Administrative Unit (SAU) 19
11 School St
Goffstown, NH 03045

Prepared by: Energy Management Consultants, Inc.
55 Industrial Way
Portland, ME 04021

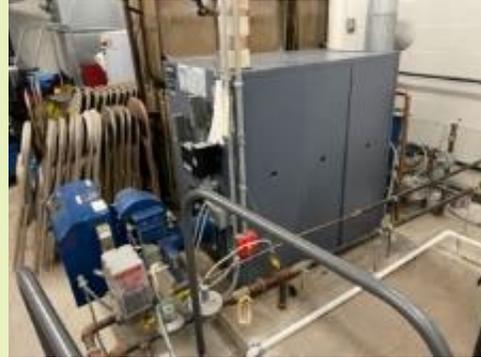
Glen Lake School Aging Boiler

One of the boilers was recently replaced. An aging boiler still remains which should be slated for replacement. This boiler still has some years of life left but a replacement based on efficiency gains of a condensing gas boiler should be

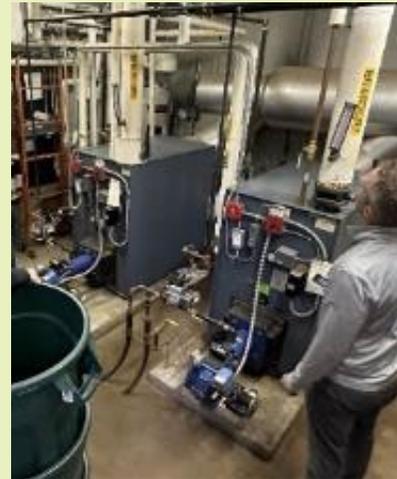
(2) cast iron Weil McLain natural gas boilers are operating at an average of 83% efficiency. Boilers would be replaced with (2) natural gas high-efficiency condensing boilers. The new system would include outside air temperature reset, automatic lead/lag operation, and building automation integration capabilities. The numerous single speed zone pumps serving different circuits of the hot water system would be combined into a variable speed duplex pump arrangement with automatic lead/lag changeover for complete redundancy. Scope would also include cleaning and sealing the boiler room floor to create a cleaner working environment.

Bartlett Elementary School Boilers

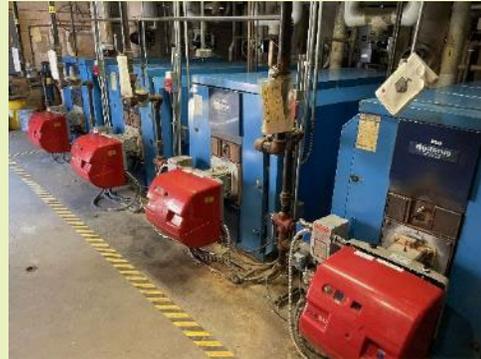
The High School is currently heated with four Buderus dual-fuel capable boilers which can operate on either oil or propane. The boilers are low efficiency compared to the technology available in high efficiency condensing boilers and for this reason it is recommended that they are replaced. It has been noted that the 2" propane supply line frosts up during the winter and causes the boilers to trip often. The propane supply piping and tanks will be studied during the development of this measure to ensure the propane supply piping is properly sized so that this does not happen. Another reason to replace these boilers is to remove the underground oil tank which has proven very difficult to get inspections completed for. With the new propane boilers, the oil tank could be removed.

Goffstown High School Boiler System

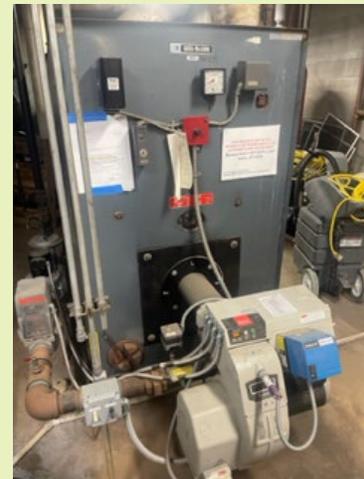
One of the existing boilers has been replaced. The remaining boiler has been tagged out of service and the requirement for the fire department to be notified before attempting to use the boiler. This leaves the school without heating redundancy while solely relying on a single boiler. The older boiler has reached its life expectancy and should be replaced. By replacing it with a high efficiency modulating boiler, efficiency gains would be realized which would lower the school's energy costs associated with the heating system. A new modulating boiler would also provide more consistent temperatures for the hot water loop providing smoother operation of the system. Scope would also include cleaning and sealing the boiler room floor to create a cleaner working environment.

Maple Avenue Elementary Aging Boiler

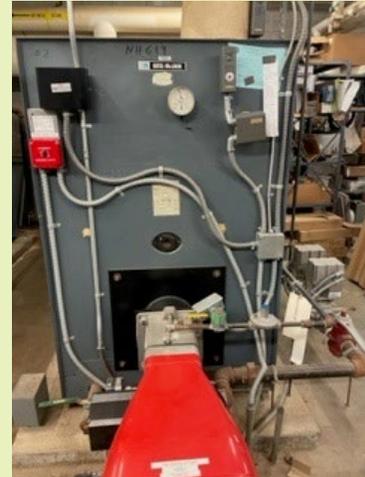
The two boilers at the Mountain View Middle school are cast iron Weil McLain boilers. These boilers are in average condition and appear to have no operational issues. The efficiency of these boilers is much lower than modern high-efficiency condensing boilers and should be considered for replacing for this reason. Energy

Mountain View Middle School Boiler

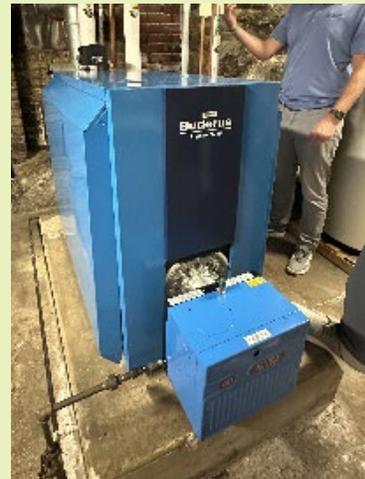
A single cast iron Buderus oil boiler serves the building. This boiler is operating at an average of 86% efficiency and provides no redundancy in the event of a failure. The boiler would be replaced with (2) propane high-efficiency condensing boilers. Existing hot water circulation pumps would remain. Scope would include completing the piping that was started for the second indirect domestic hot water tank. Scope would also include cleaning and sealing the boiler room floor to create a cleaner working environment.

SAU Office Boiler

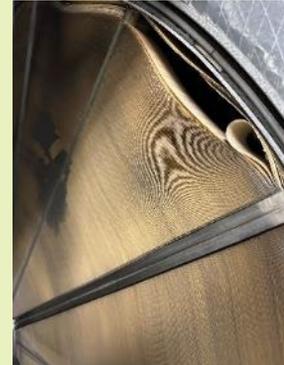
The wheel for ERV-1 was found to be in very poor condition and should be replaced. Inspections found that the wheel was very dirty which will cause a high pressure drop across the wheel and drastically reduces the ventilation airflow for the cafeteria/gym space. The wheel was also found to be delaminating along the edges of the wheel. If this deconstruction continues, pieces of the wheel could be pulled into the fan causing a fan failure. These conditions also reduce the energy recovery efficiency of the unit which results in higher utility costs than normal.

*Bartlett Elementary School
ERV-1 Energy Wheel*

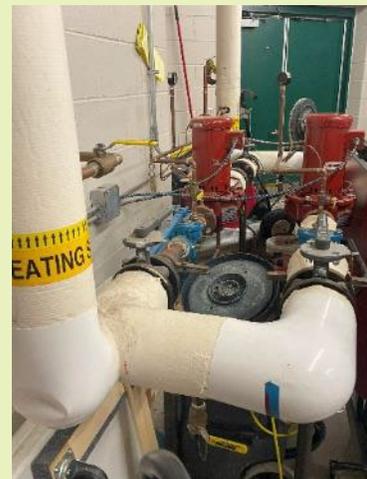
Glen Lake School Hot Water Pumps

motors are rated to handle VFDs and it is recommended that VFDs are installed. This will provide the system with soft-start capabilities and the ability to reduce speeds during warmer months when full flow is not required. Reducing the pump speed will reduce the electrical consumption associated with these large pumps.

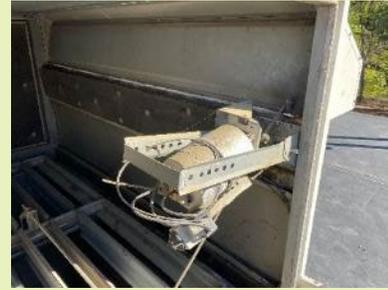
The heating ventilator unit located on the roof has passed its useful life and is in very poor condition. The controls associated with this unit are pneumatic which are also in poor condition and are likely not controlling temperatures accurately. This old control system is also not capable of modern high-efficiency sequence of operations such as demand control ventilation based off CO₂ in the building. By replacing this equipment with an energy recovery ventilator, VFDs and new controls, a great amount of energy can be saved while also improving the temperature control of the building. Overall, new equipment serving ventilation to the building would incorporate energy recovery, optimal start scheduling, demand control ventilation and variable frequency drives on the fans to optimize the energy expended with this equipment.

Maple Avenue Elementary Air Handler with Pneumatic Actuator

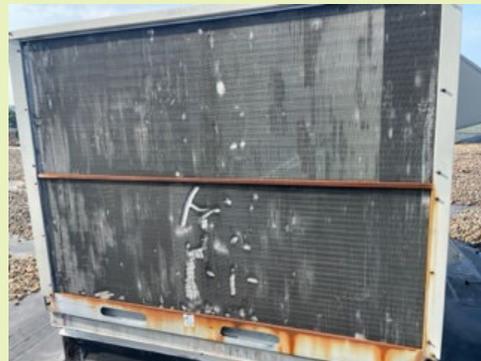
The air handling equipment at the Middle School is comprised of (2) roof top units (RTU) and (3) heating ventilators (HV). The RTUs serve the office spaces with heating, cooling, and ventilation air while the HV units serve heating and ventilation to general spaces and interior rooms that are not served directly by the classroom unit ventilators. All of these air handlers have hit their life expectancy and should be replaced before an equipment failure occurs. In general, new equipment serving ventilation to the building would incorporate energy recovery, optimal start scheduling, demand control ventilation and variable frequency drives on the fans to optimize the energy expended with this equipment.

Mountain View Middle School Roof Top Unit in Poor Condition

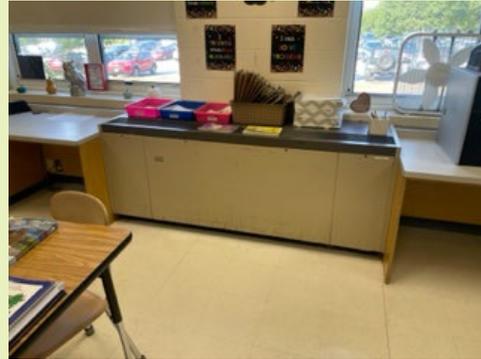
The classroom unit ventilators in the Mountain View Middle School are past their useful life and should be replaced with a modern model of the same footprint. These units serve the classroom with heating and ventilation. Modern units couple with a new control system have energy reducing features such as variable speed fan motors, demand control ventilation based off CO₂, and optimal start scheduling which all reduce energy consumption and provide a better classroom environment than the equipment currently in use.

Mountain View Middle School Classroom Unit Ventilators

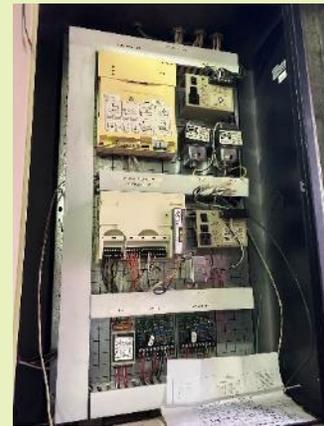
Bartlett Elementary School has a very old Honeywell building automation system that has long surpassed its useful life. The existing system is likely hard if not impossible to get replacement parts for. The proprietary nature of this control system leaves little options for the district to source competitive pricing if they needed to source a replacement controller. Although direct digital controls (DDC) serve the major equipment within the building, much of the building is still served by an ancient pneumatic controls system. Pneumatic systems are inherently standalone systems which offer zero insight into how the system is operating and if any problems are present. Also, a pneumatic system requires an air compressor which results in costly operation and maintenance. It is recommended that the existing Honeywell CBUS controllers and all pneumatic devices be removed, and a new BACnet DDC controls system be installed to fully automate the building. This would create an open architecture and remove all proprietary controllers from the building. The Niagara existing JACE 8000 controller should be upgraded to the latest version of software and firmware.

*Bartlett Elementary School
Boiler Room Controller*

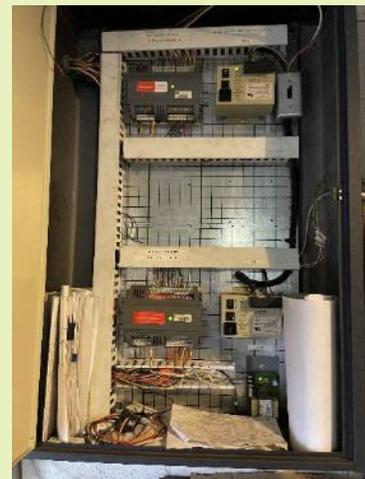
The existing control system in the High School is a Honeywell Comfort Point system. This system is proprietary and greatly limits the district's ability to have it serviced from multiple vendors. There are about 50 controllers on site communicating on the LON protocol. LON is considered a legacy communications protocol which has been surpassed by ASHRAE's BACnet protocol which is used by every control manufacturer at this point. It is recommended that the existing controllers be replaced with BACnet controllers with a new BACnet communications bus extended throughout the school. This would create an open architecture and remove all proprietary controllers from the building. The existing Niagara JACE 600 controller should be replaced with the latest model JACE 8000 (soon to

Goffstown High School Controllers

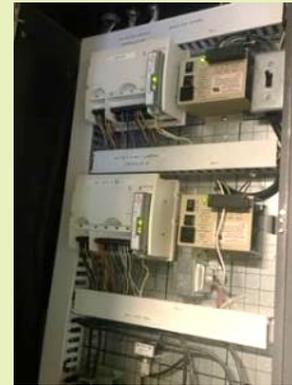
Much of the HVAC system in this school is still served by an aging pneumatic control system which is greatly passed the end of its useful life. Pneumatic control systems are inherently simplistic with the operations they can perform and costly to operate due to the need for an air compressor to continually operate. Modern building automation systems allow the latest in energy reduction strategies to be utilized in the sequence of operations of the systems being served. This translates to energy savings associated with the HVAC system which is typically a large portion of the building's energy usage. It is recommended that the existing Honeywell CBUS controllers and all pneumatic devices be removed, and a new BACnet DDC controls system be installed to fully automate the building. This would create an open architecture and remove all proprietary controllers from the building. The existing Niagara JACE 8000 controller should be upgraded to the latest version of software and firmware.

*Maple Avenue Elementary
Controls*

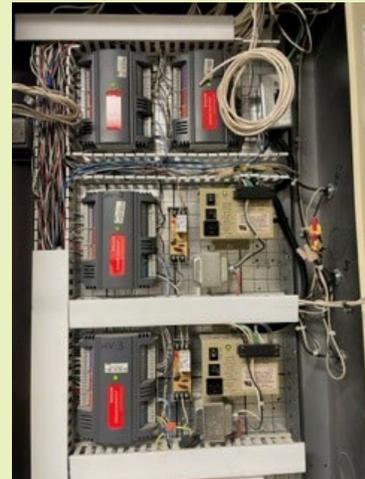
The existing control system in the Middle School is a Honeywell Comfort Point system. This system is proprietary and greatly limits the district’s ability to have it serviced from multiple vendors. There are about 79 controllers on site communicating on the LON protocol. LON is considered a legacy communications protocol which has been surpassed by ASHRAE’s BACnet protocol which is used by every control manufacturer at this point. It is recommended that the existing controllers be replaced with BACnet controllers with a new BACnet communications bus extended throughout the school. This would create an open architecture and remove all proprietary controllers from the building. The existing Niagara JACE 600 controller should be replaced with the latest model JACE 8000 (soon to be 9000) with the latest version of software and firmware installed.

*Mountain View Middle School
Controllers*

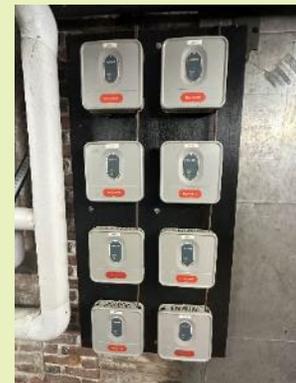
The SAU Office does not currently have a building automation system. The heating system currently operates via Honeywell thermostats which wirelessly communicate with modules in the basement boiler room. While this does provide heating control, there is no way to monitor the system or receive alarms when something is not working. A new Niagara based automation system would be installed to properly monitor and control the building. This includes monitoring the boiler and domestic hot water temperatures and boiler status and fault conditions.

SAU Office Controls

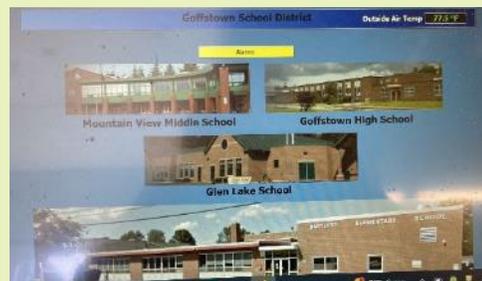
*Goffstown School District Building Automation
System Graphics*

A district wide building automation system is the ultimate tool in monitoring and proactive maintenance for the associated buildings. By bringing all the buildings into one system, the maintenance staff can quickly and efficiently check on all the buildings with a single login. Dependent on local IT Department policies, the system can be accessed remotely so that when an alarm is received, nearly instant response to putting eyes on the issue is possible, even afterhours. Since most modern systems are web-friendly, no software is required to access the system. This allows the maintenance staff to utilize tablets or phones to assist them in operating the

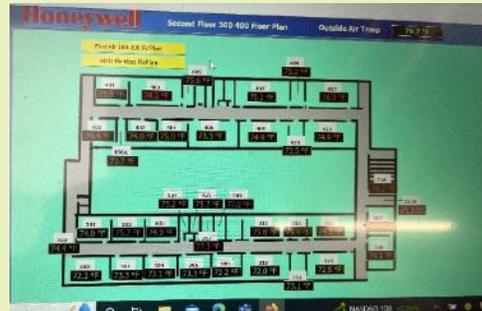
Goffstown High School Building Automation System Graphics

The District currently has a Niagara based building automation system which ties all of the schools together into a server. This communication is done via the Niagara JACE controller located in each building. The server should be upgraded to the latest software version to ensure all cyber security patches are present. Depending on the current version, new features are likely available for use. The graphics would be revamped, which would give the system a more modern look and feel while adding better navigation across the system’s graphical user interface. All the new controllers installed in the buildings as part of the building automation upgrade measure would be added to these new graphics. All alarms and trending would be integrated from each building into the server for long term archiving.

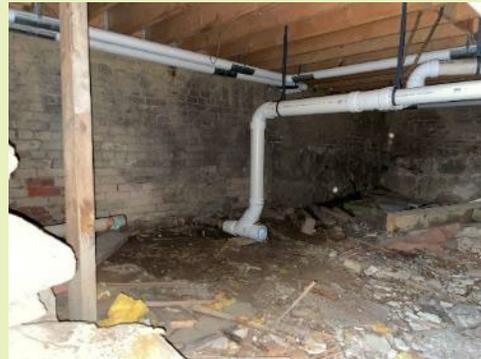
The SAU Office basement is within the building envelope but is not insulated in any way. The basement has the distinct “musty” smell of an older residential basement which is an indication of high humidity. Although the space is not typically occupied, most of the paper file storage for the school district is shelved in the basement. With the lack of proper insulation and air sealing, the basement is subject to being a high-humidity environment which could damage the paper files. Insulating the basement will indirectly keep the floor of the floor above a warmer temperature which will create a more comfortable environment in the occupied areas above which will also save on heating costs. The exterior foundation would be insulated with spray foam paying close attention to any pipe or wire penetrations, windows, and cracks.

SAU Office Basement Conditions

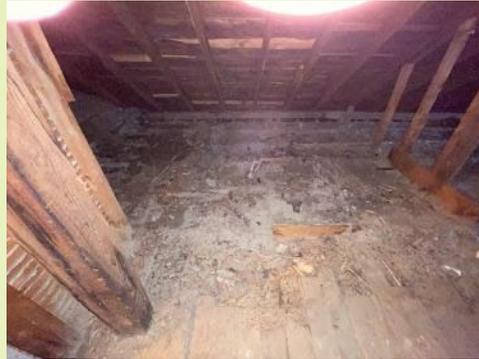
The SAU Office has minimal attic insulation and poor air sealing throughout. The eaves were noticed to have almost no insulation which may cause ice dams on the roof during the winter which could cause water to infiltrate under the shingles of the roof and cause water damage inside the building. Adding a proper layer of cellulose insulation across the floor and potentially spray foaming the eaves would add a highly efficient insulation value to the attic of the building.

SAU Office Attic Insulation

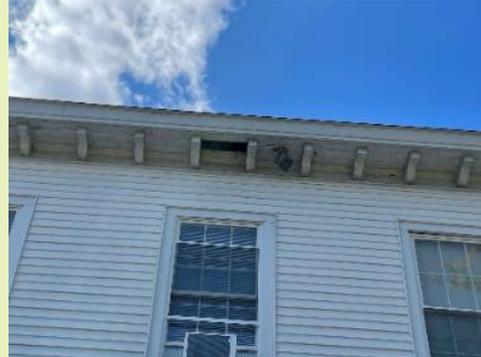
Overall, for the age of the building, the SAU office is in good condition. However, it was noticed during the exterior portion of the site walk that there are a few areas of concern regarding weatherization. Most of the concerns are associated with the soffit of the building. This area shows signs of peeling paint, rotting wood, and even an open hole in one section. The open hole is most concerning since this is a direct entry for small animals and insects to get into the building. There were multiple yellow jacket nests around the building and eventually an infestation of the attic may occur. The hole is also the most susceptible to weather getting into the unprotected portion of the building. The brick foundation also has some portions requiring some mortar repair. The bricks in some areas are just sitting with large voids around them lacking mortar. These areas should be repaired to maintain the integrity of the building.

SAU Office Hole in Soffit

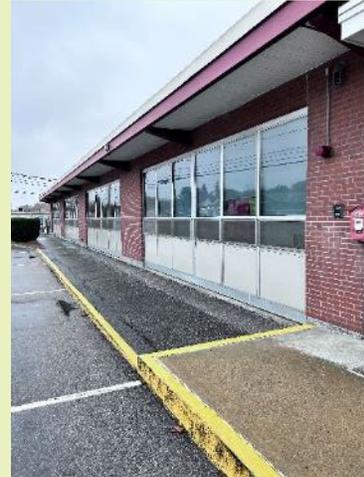
Many of the windows at Bartlett Elementary have been replaced over the recent years and there are still many remaining windows to replace. The windows that have been identified as having the largest efficiency gains associated with them are windows like the front windows as shown in the photo. This floor to ceiling window unit severely lacks quality insulative properties as modern energy efficient models would offer. Due to the size of these windows, there would be noticeable temperature improvements in the classroom spaces which have these windows. With better insulated windows (and most of the wall) the heating system would also not be required to produce as much heat which would save on heating plant energy consumed. It is recommended to replace the remaining windows in this school with a highly efficient window option.

Bartlett Elementary Front Windows

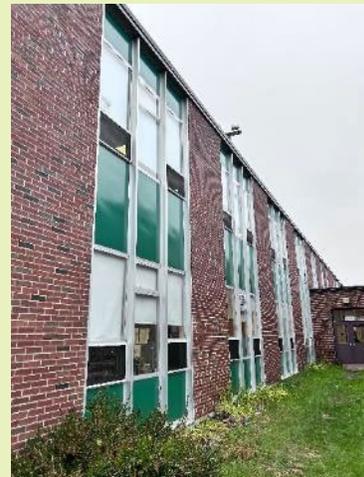
Many of the windows at the High School have been replaced over the recent years and there are still many remaining windows to replace. Some of the older windows have begun to lose seals which severely degrades the windows ability to insulate the outside temperature from the inside. This causes cool temperatures near the windows during the winter months and puts an extra load on the heating system which increases the costs associated with the heating plant. To stay ahead of window failures, it is recommended to complete a window replacement for the remainder of the school. This will ensure that energy is not being wasted due to faulty windows and will ensure a better indoor environmental comfort level for the students.

Goffstown High School Windows

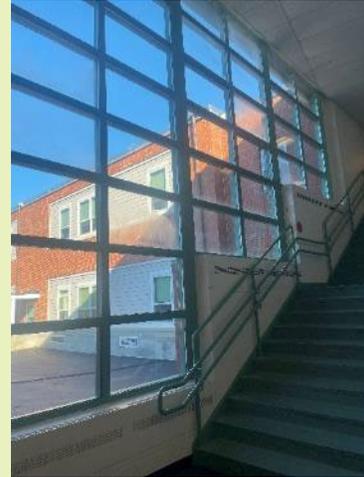
The Maple Avenue Elementary School has recently received new windows and most of them are in great condition. There is a section of windows that is of concern, however. The window section shown in the photo generally does not provide enough insulation value in the winter months for the existing heating that is available in the space. This causes cool temperatures in the spaces adjacent to this area and puts an extra load on the heating system. At first, adding additional heat was a logical solution. A deeper review of the windows determined that some of the window seals have failed, which is indicative of moisture buildup in some of the windows. Overall, this window structure has replacement options that can provide much better temperature resistance (R-Value) which would potentially eliminate the need for additional heat in the space (and the added costs to generate and distribute that heat). It is recommended that this window section be replaced with a more energy-efficient option.

Maple Avenue Elementary Windows Cause Cold Conditions in Vicinity

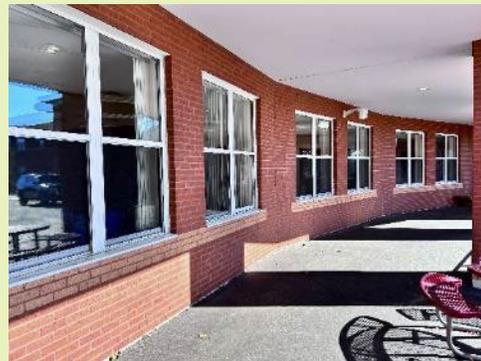
The windows in the Mountain View Middle School are original to the building and some of them have begun to fail over the years. Some of the windows have lost their seals and moisture can be found between the panes of glass. Other windows have failed in ways that prevent the user from safely operating the window without it wanting to fall out of its track. Since all the windows are the same age, they are likely in similar conditions and for this reason it is recommended to replace all the windows which will provide energy efficiency gains with the increased R-Value found in modern windows. If replacing all the windows at once is too much to take on financially, it is recommended to at least replace the windows that have already failed as phase 1 with a plan in place to phase a complete window replacement over the next few years.

Mountain View Middle School Existing 30-Year-Old Windows

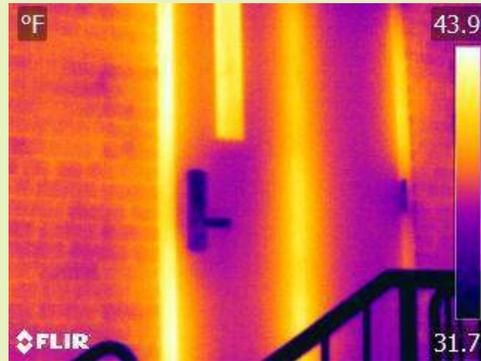
The exterior doors at Bartlett Elementary, for the most part, are structurally and cosmetically in good condition. The air sealing around the doors is what is lacking for most of the doors. A good air seal is vital to keep the outside air out and the conditioned air in. When air sealing has been compromised or does not exist altogether, this threshold between indoors and outdoors approaches zero. On cold windy days the areas in proximity to the doors will feel drafty and cool. This will cause the heating system to heat more than should be required while raising energy consumption. By adding weather stripping around the doors, door sweeps and astragal (the seal between the doors), the doors will perform much better and help lower the energy consumption of the building.

Bartlett Elementary Exterior Door Heat Loss

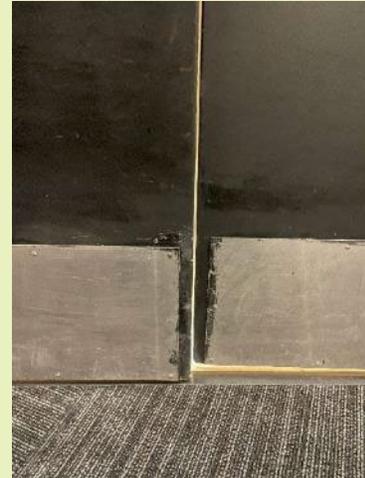
Many of the exterior doors in the High School have been replaced in previous years. About 11 doors remain to be replaced. These remaining doors have various condition levels. Some of them have large air gaps around them which will cause a significant amount of air infiltration. This will likely cause the area to be drafty and cold during the winter months, which will put an unnecessary load on the heating system. The four (4) access doors for the auditorium are also in poor shape and should be replaced. While these doors are not all exterior doors, the condition of the doors are poor. They show excessive signs of wear and use, and some have large gaps between them.

Goffstown High School Exterior Door Showing a Large Air Gap

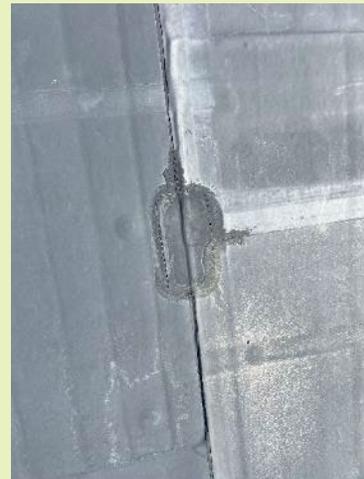
With some immediate repairs, this roof should last another 5-10 years. Some seams are showing signs of drying out which will lead to cracking and leaking. These seams should be repaired. This is mostly seen around roof patches and other penetrations such as around roof mounted HVAC equipment. The flashing on the chimney needs to be replaced or at least sealed with caulking. The roof drains need to be cleaned as leaves, pine needles and moss have mostly clogged some of the drain grates. One of the roof drain grates appears to be missing and should be replaced before the drainpipe becomes clogged with debris. The large satellite dish on the roof is mounted via cinderblock ballast with an extra layer of rubber matting under the blocks to protect the EPDM from damage. While this is all fine, the rim of the dish is sitting on the unprotected EPDM. When the wind blows the dish likely moves and will wear out the unprotected roofing eventually causing a failure to the material. The dish should be repositioned to be self-supported without laying on the unprotected EPDM. When this roof is replaced, the roof pitching should be improved to help remove the standing water that was present during one of the walk throughs. While a core sample of the roof was not taken in time for this report, it is expected that some insulation will be required to meet R30 requirements and should be added when the roof is replaced.

Goffstown High School Roof Showing Signs of Deterioration

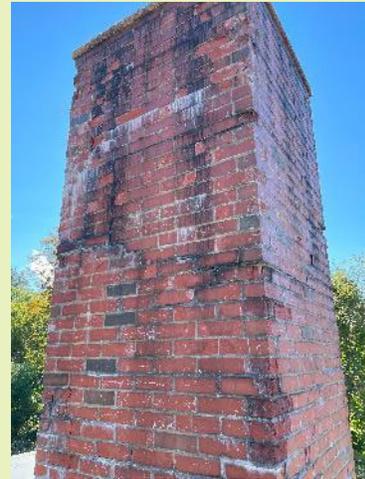
Maple Avenue Elementary Chimney Condition

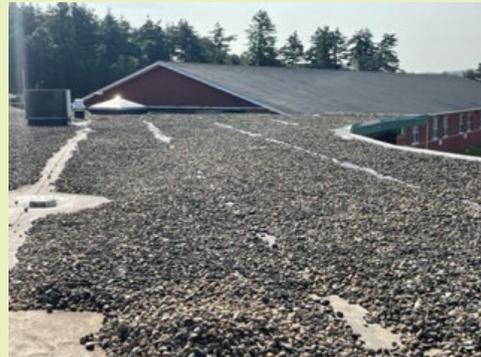
The roof at Mountain View Middle School has proved troublesome over the years with constant issues having to be addressed. The ballasted rubber roof should be replaced with a fully adhered EPDM membrane roof. During this installation, the existing rock ballast would be removed along with the existing membrane. Depending on the level and condition of the insulation under the existing membrane, insulation would be added to ensure the roof met the R30 requirements for insulation.

Mountain View Middle School Roof Section

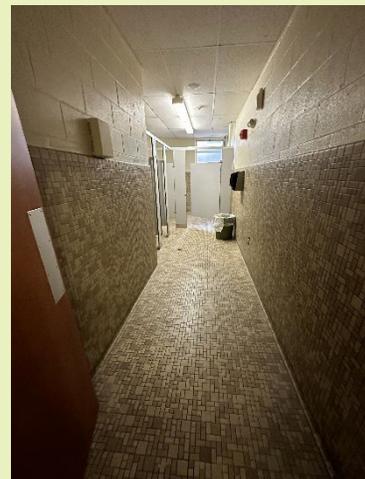
The bathrooms at Bartlett Elementary had no glaring ADA deficiencies but would benefit from a remodel based on the overall condition. Many of the fixtures are showing signs of wear. The flooring and wall tiling is very dated and could be replaced to bring a more modern and cleaner look for the young students using the facilities. The heating pipe insulation in a few locations was in poor condition and should be reinsulated to protect the children

Bartlett Elementary Bathroom

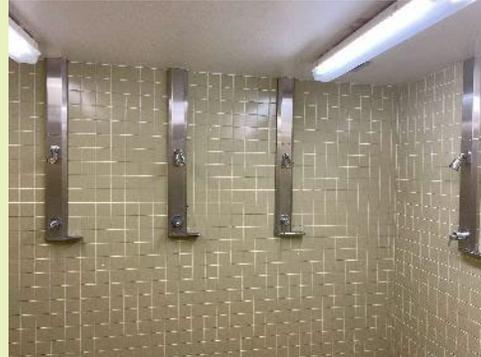
The boy's bathroom outside the gym is original to the building and should be modernized. This should be accomplished like the girl's bathroom in the same vicinity. ADA compliance should be implemented during this renovation to make sure that the facility stays accessible to students and faculty with disabilities. Based on culture changes over the years, it is recommended to modify the Boys Locker Room showers from having an open multi-user shower to private stall showers. The same shower room footprint could be used to install shower stalls. At least one of the stalls should be ADA compliant.

Goffstown High School Group Shower

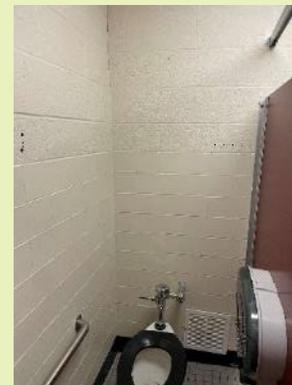
*Maple Avenue Elementary
Bathroom Stall not ADA
Compliant*

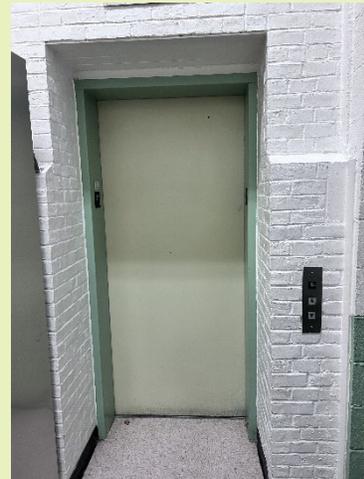
The elevator in Bartlett Elementary is an older model elevator built into a cement wall. The access to the elevator and the elevator cab does not meet the current ADA requirements for entrance and turning radius clearances. It is recommended to replace the elevator and entrance with a modern elevator ensuring that everything is within the requirements of ADA.

Bartlett Elementary Elevator

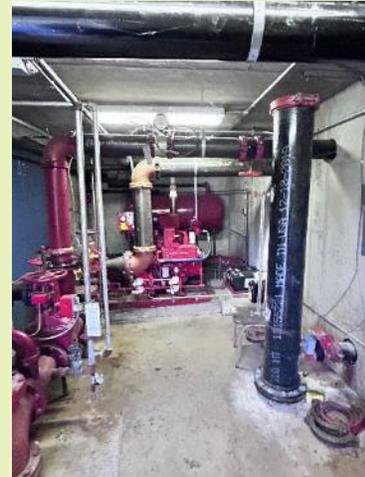
The fire pump house at the Mountain View Middle School is a small outbuilding located adjacent to the school. This building houses a diesel fire pump and all the associated piping and controls to activate the fire pump upon a sprinkler in the school activating. The fire pump draws water from an underground fire cistern which holds water on standby specifically for fire suppression. The fire cistern has been identified as requiring a replacement to maintain certified operation of the fire suppression system. It is recommended that this fire cistern is replaced with a new tank meeting NFPA 22 Tank Standards as well as local codes and standards.

Mountain View Middle School Fire Pump House

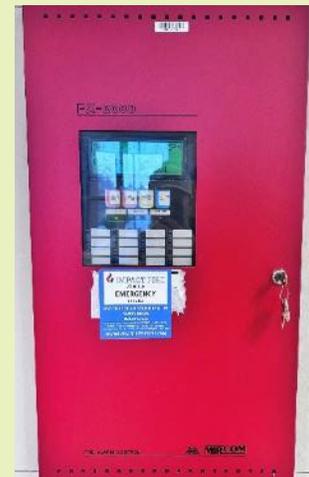
In feedback from the school maintenance personnel, the existing Mircom fire alarm panel should be replaced. The existing alarm panel has limited local support which makes it difficult to maintain and make modifications to. It is recommended to replace the panel with a different brand which will be more conducive to multiple local support companies able to work on the panel in the future.

Mountain View Middle School Fire Alarm Panel

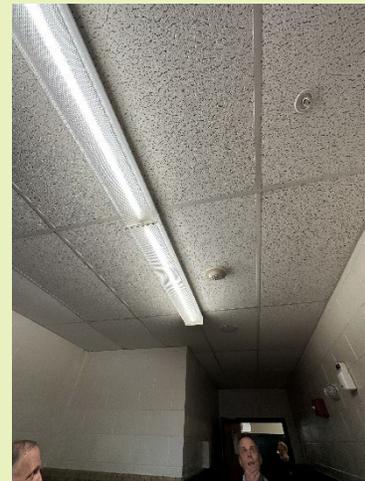
modular building also contains multiple luminaire types with T8 fluorescent technology as well as compact fluorescent technology. Classroom 317 contains flush mounted troffer fixtures and will be replaced with an LED troffer kit that contains advanced wireless controls. All other areas with T8 technology will have LED retrofit kits without wireless controls due to the cost/benefit. The compact fluorescent lights will be replaced by the equivalent LED lamps.

Bartlett Elementary T8 Lighting

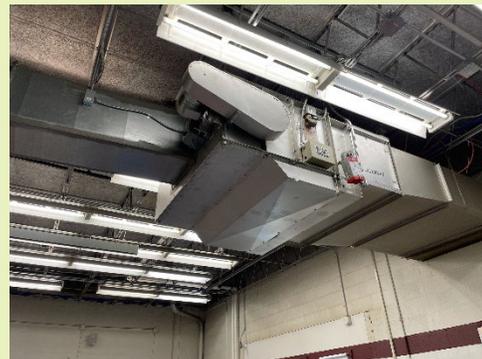
The High School contains multiple luminaire types with T8 fluorescent, Compact Fluorescent and other legacy technologies. The majority of the fixtures in the school

are flush mounted troffer fixtures with T8 fluorescent lamps. These troffer fixtures will be replaced with LED volumetric retrofit kits containing advanced wireless controls. Additionally, there are pendant mount fixtures utilizing T8 fluorescent technology that will be replaced with new LED fixture equivalents and include advanced wireless controls. Existing recessed fixtures with compact fluorescent lamps, to be replaced with new LED recessed lights. Maintenance, restrooms,

Goffstown High School T8 Lighting

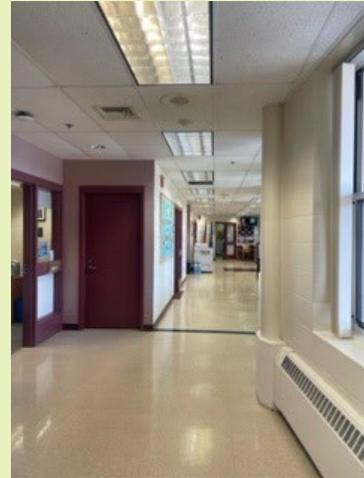
Mountain View Middle School contains multiple luminaire types with T8 fluorescent, Compact Fluorescent, and other legacy technologies. Most of the fixtures (~75%) in the school are flush mounted troffer fixtures with T8 fluorescent lamps. These troffer fixtures will be replaced with LED volumetric retrofit kits containing advanced wireless controls. Additionally, there are surface mount fixtures utilizing T8 fluorescent technology that will be replaced with new LED fixture equivalents and include advanced wireless controls. Recessed can fixtures with compact fluorescent lamps, to be replaced with new LED recessed fixtures. Maintenance rooms, restrooms, storage, utility rooms and other low run hour areas containing industrial, strip, and wall mounted fixtures with T8 fluorescent technology to retrofit with LED bar-kits. Finally, existing LEDs remain as is. This includes the gymnasium and exterior fixtures. The Gymnasium LED fixtures have advanced wireless controls. Proposed advanced Bluetooth controls to match existing controls.

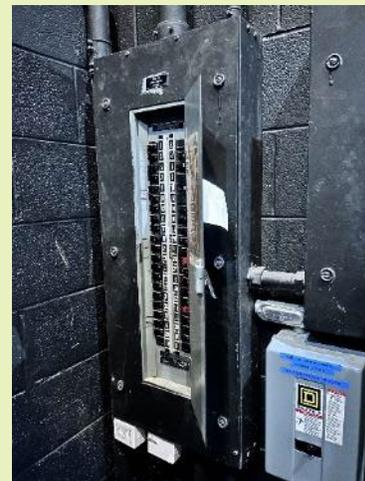
The High School has numerous electrical distribution panels throughout the facility. There are many different manufacturers for the various panels. The specific manufacturer that is being recommended for replacement are the panel manufactured by Federal Pacific. While the Federal Pacific panel was historically very popular, they ended up going out of business. Since replacement parts and breakers are no longer made, servicing the panels is very difficult. The company's products also do not have a stellar safety record with breakers that don't trip causing fires when components overheat during an electrical fault. This product has no place in a school filled with children and should be replaced. This measure will replace all the Federal Pacific panels with modern UL listed panels meeting all current national electric code (NEC) requirements.

*Goffstown High School Electrical
Distribution Panel*

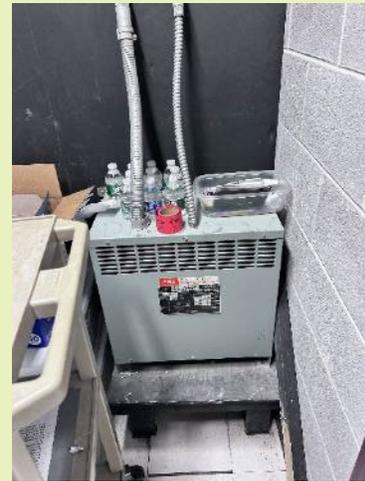
There are seven (7) building step-down transformers in the High School that are being recommended for replacement. These transformers step down the primary 480V service to 120/208V power which feeds various electrical distribution panels across the school. The condition of the transformers somewhat varies but all are recommended for replacement due to their age, condition, and nameplate efficiency rating.

Goffstown High School Building Transformer

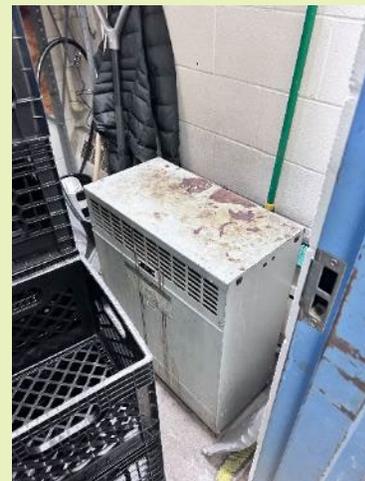
There are eleven (11) building step-down transformers in Mountain View Middle School that are being recommended for replacement. These transformers step down the primary 480V service to 120/208V power which feeds various electrical distribution panels across the school. The condition of the transformers somewhat varies but all are recommended for replacement due to their age, condition, and nameplate efficiency rating.

Mountain View Middle School Building Transformer

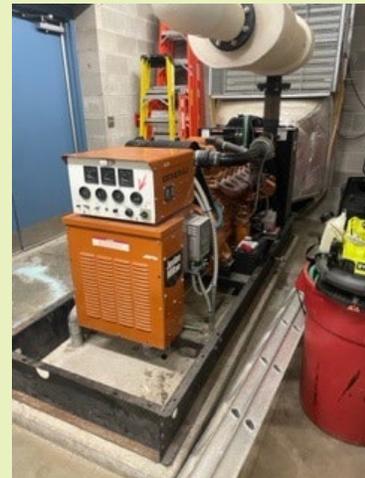
The generator and the associated transfer switch are quite past their usable life. Although the exact age is not clear at this point, the school would benefit from a new model that would have the added benefits listed above. It is recommended that a new generator be installed along with a new transfer switch. The new generator should be sized larger than the existing unit so that there is enough capacity for the kitchen equipment to be tied in. If there was other critical equipment that was also not tied into the existing system, capacity and the wiring infrastructure would be included to support that equipment as well.

*Mountain View Middle School
Generator*

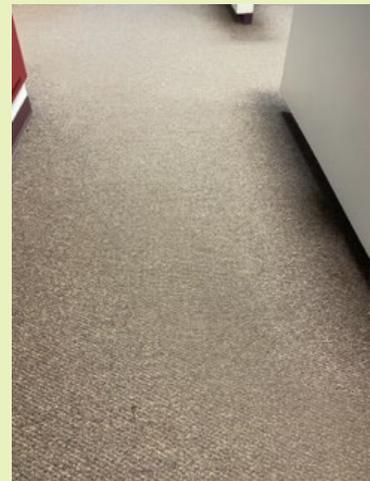
*Goffstown High School Carpet
Showing Signs of Wear and Tear*

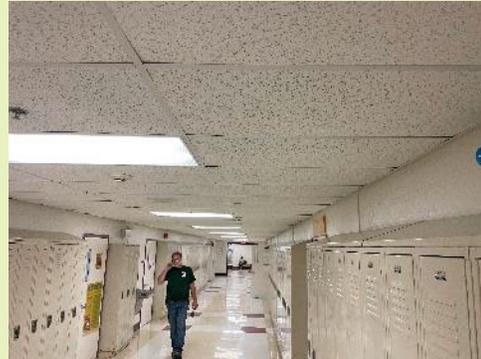
Goffstown High School Ceiling Tiles Curling in the Corners

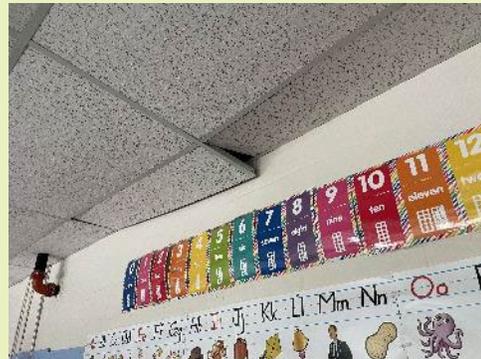
Maple Avenue Elementary Ceiling Tiles with Large Gap

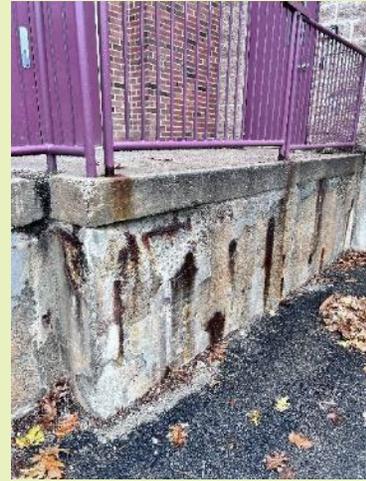
Goffstown High School Loading dock area concrete in need of repairs

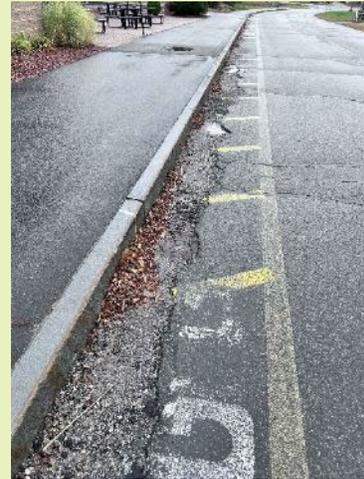
Goffstown High School Pavement Showing Signs of Deterioration

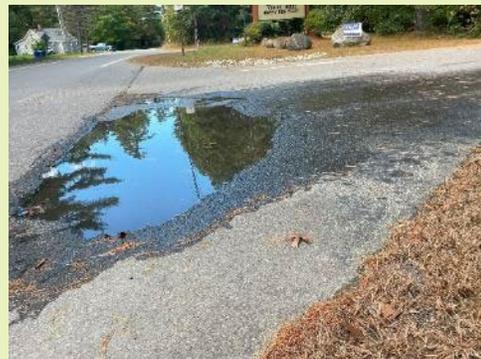
Glen Lake School Roadway Entrance Pooling

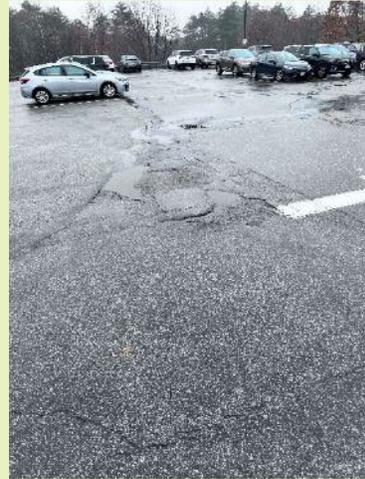
*Mountain View Middle School
Parking Lot Deterioration*

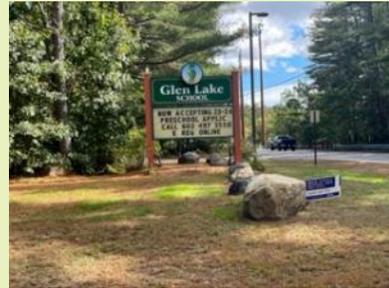
The existing message board for this school requires one of the employees to manually update the sign's message. This static message is limited to the number of characters available based on the size of the sign. This often results in single cryptic messages that have limited detail. A new digital sign would allow the school to rotate through different messages and graphics allowing better communication between the school and the community.

Glen Lake School Message Board

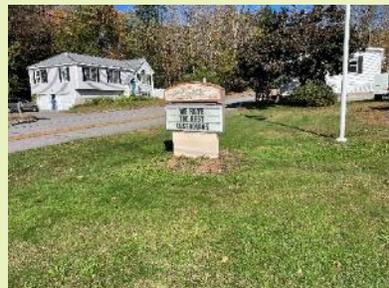
The existing message board for this school requires one of the employees to manually update the sign's message. This static message is limited to the number of characters available based on the size of the sign. This often results in single cryptic messages that have limited detail. A new digital sign would allow the school to rotate through different messages and graphics allowing better communication between the school and the community. This sign is also showing signs of aging which takes away from the vibrant image of the school.

Maple Avenue Elementary Message Board

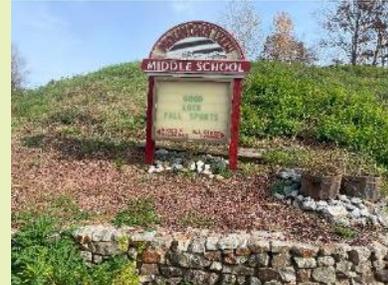
The existing message board for this school requires one of the employees to manually update the sign's message. This static message is limited to the number of characters available based on the size of the sign. This often results in single cryptic messages that have limited detail. A new digital sign would allow the school to rotate through different messages and graphics allowing better communication between the school and the community. This sign is also showing signs of aging which takes away from the vibrant image of the school.

Mount View Middle School Message Board

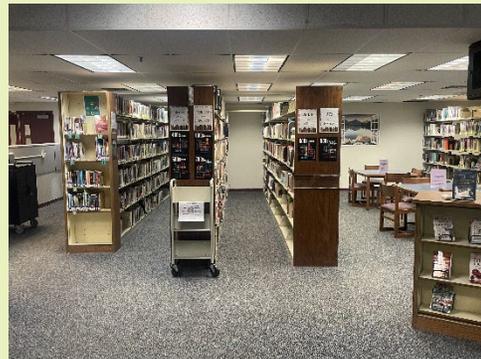
Goffstown High School Library Furniture in Poor Condition
